Manhole Inspection Summary

Manhole # S13YY1010MH

Insp Date: **7/25/06 12:22 PM**

Location Address: **2304 KEN OAK RD**

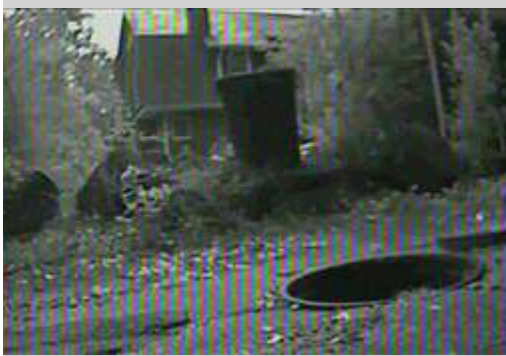
Location View

Comments **Cracks in pavement around manhole. Possible source of infiltration.**

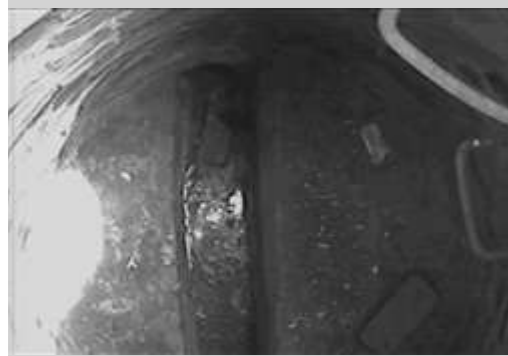
Top View

Bench and Channel debris.

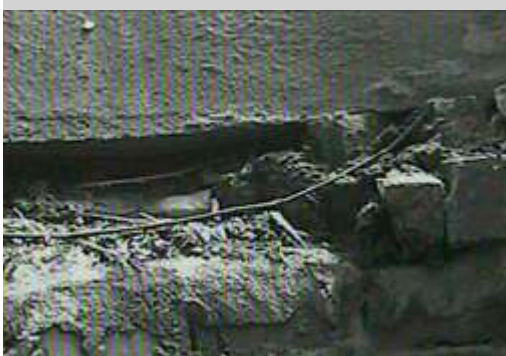
Defect

Frame leaks. Adjustment deterioration, loose brick, and infiltration.

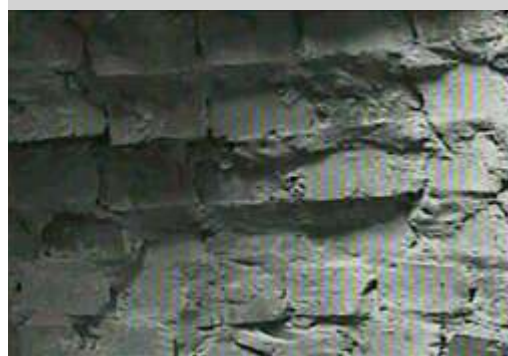
Defect

Corbel and Barrel deterioration and infiltration.

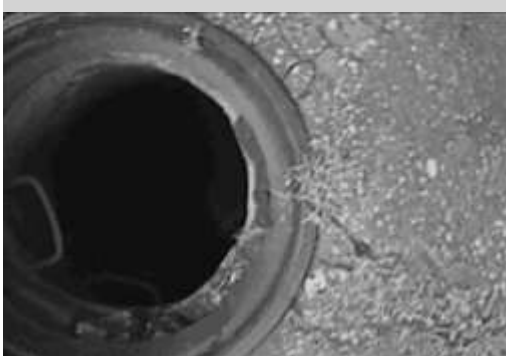
Defect

Frame offset.

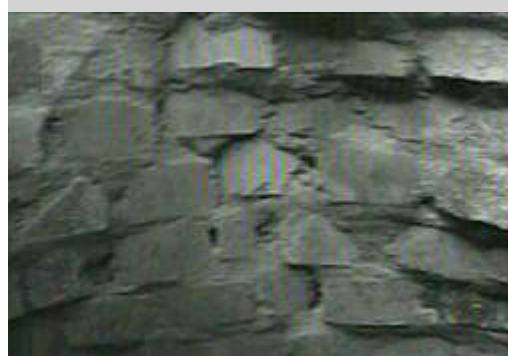
Defect

Corbel infiltration.

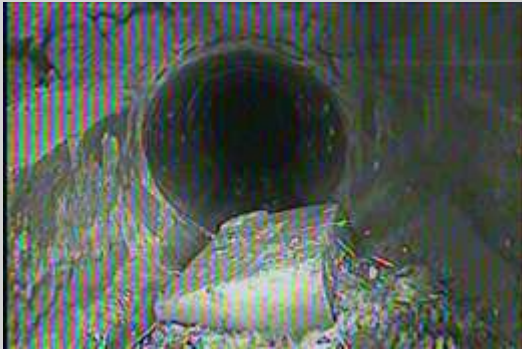
8 in. Circular Gravity Sewer Pipe Out @ 12 O'Clock

Channel debris.

Infiltration: **Evidence** Pipe Seal Cond: **Cracked**

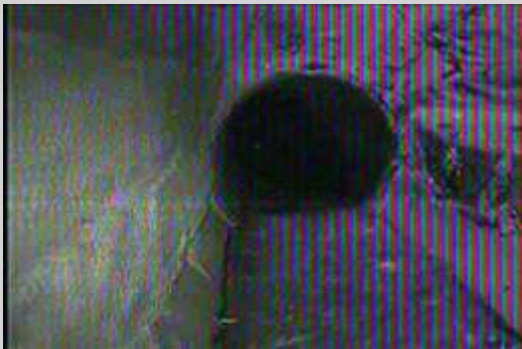
8 in. Circular Gravity Sewer Pipe In @ 6 O'Clock

Channel deterioration.

Deposits: ☐ None ☒ **Mud** ☐ Sludge ☒ **Debris** ☒ **Grease**

Silt Depth: **1.5** (in.) Deposits Extent: **Light**

Infiltration: **None** Pipe Seal Cond: **Cracked**
